# The Innovative Use of High Pressure Jetting of Thin Diaphragm Walls To Construct Hydraulic Control Barriers

Richard C. Landis

E.I. DuPont de Nemours and Company, Wilmington, DE, USA

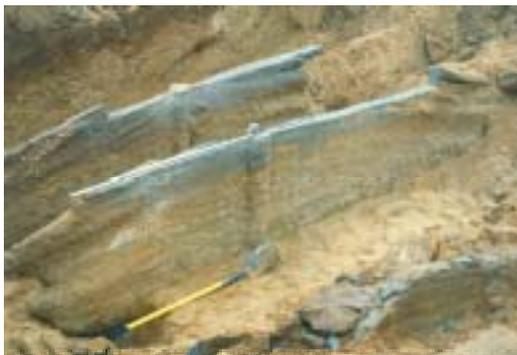
Figure 1. Photograph of high pressure jet grouted panels (high cement / low bentonite slurry)

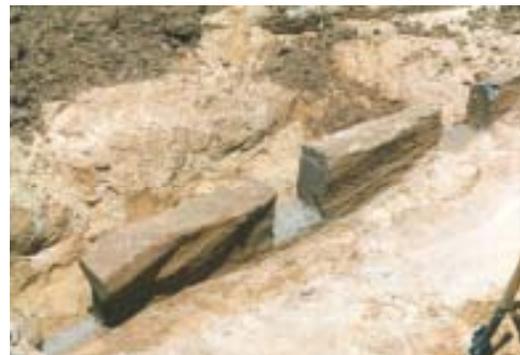
Figure 2. Photograph of a high pressure jet grouted panel (high bentonite / low cement slurry)

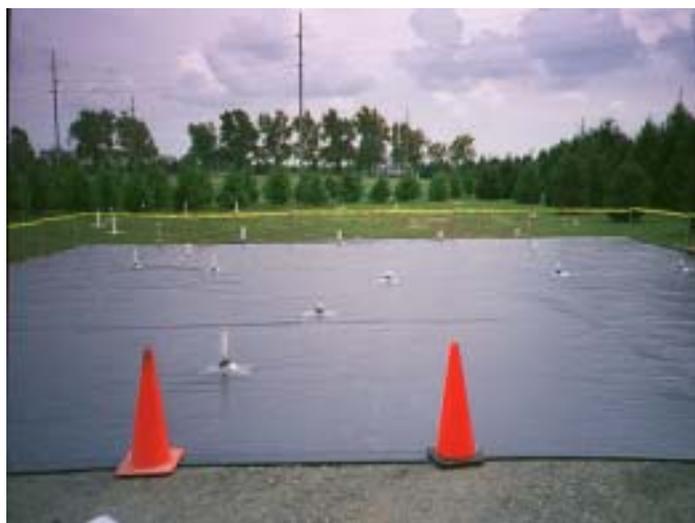
Figure 4. Photograph of the geomembrane cover and seals around the monitoring wells

In a pilot demonstration project a circular cofferdam was jet grouted with a diameter of 34 feet consisting of 12 inter-connecting panels with an effective tip to tip distance of 9.3 feet (Figure 3). The cofferdam was constructed by jet grouting at roughly 6000 psi and a drill string extraction rate of roughly 64 inches per minute. Based upon lab testing of cores from the nearby test panels the cement-bentonite slurry had an *in situ* hydraulic conductivity of roughly  $1.0 \times 10^{-7}$  cm/sec. The panels of the cofferdam were jetted roughly 7 feet into the underlying confining unit at a depth of 36 feet below ground surface. Based upon down hole inclination measurements of the drill string and the resultant an as-built drawing, several additional panels were jetted to help ensure continuity at the intersections between panels (Figure 3). Three pairs of monitoring wells were installed and screened within the 10 foot saturated zone to monitor water levels inside and outside of the cofferdam to determine the gradient across the panels. The cofferdam was then covered with a geomembrane to prevent precipitation infiltration (Figure 4).
